FIFTH FIVE-YEAR REVIEW REPORT FOR UNITED CHROME PRODUCTS, INC. SUPERFUND SITE BENTON COUNTY, OREGON

APRIL 2017

U.S. Environmental Protection Agency Region 10 Seattle, Washington

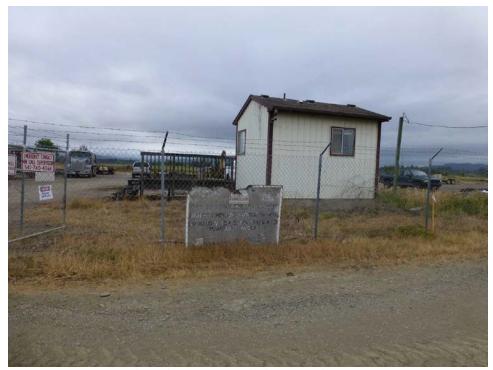
Fencing, signage and building near site entrance

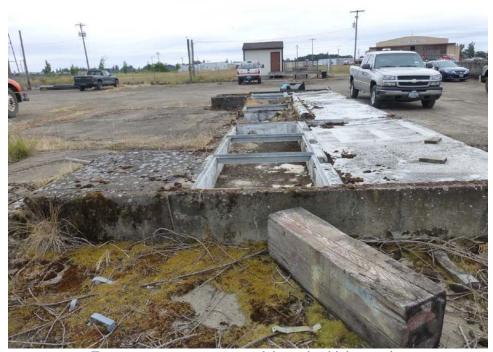
Former concrete structures, slabs and vehicles on site

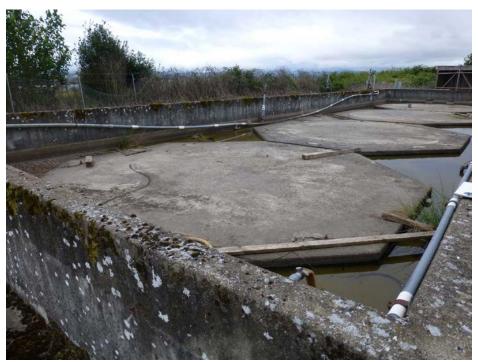
Former tank pads

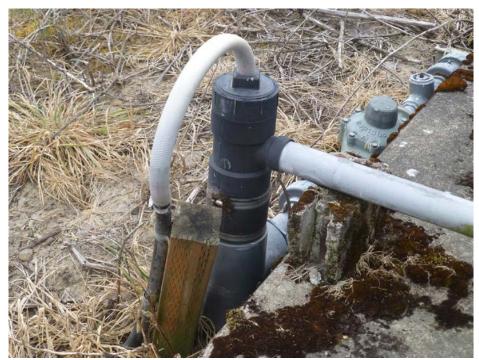
Location where DW-8 pumps to sewer (next to tank pads above)

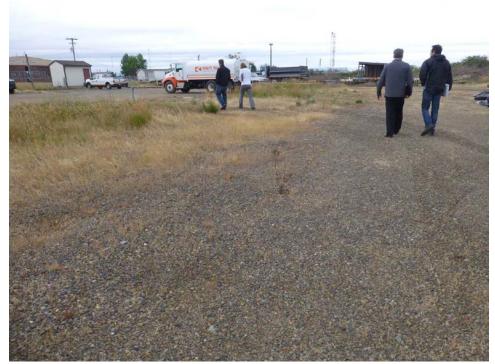
Graveled areas where previous soil excavations took place

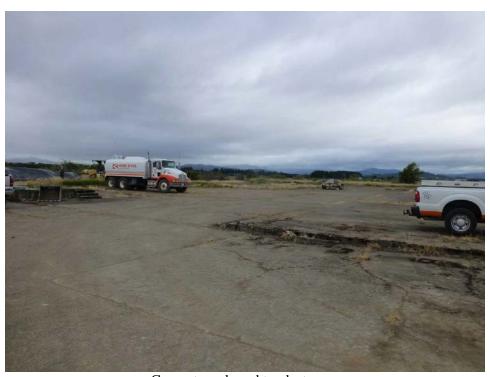
Concrete pads and truck storage

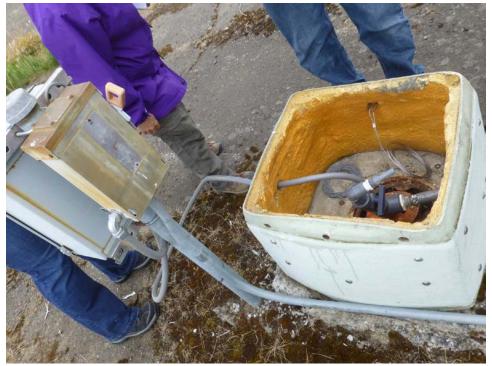
A. G	roundwater Extraction Wells	s, Pumps and Pipelines	☑ Applicable ☐ N/A
1.	Pumps, Wellhead Plumbing	g and Electrical	
	☐ Good condition ☐ A	ll required wells properly operating	g \square Needs maintenance \square N/A
	Remarks: <u>DW-8 (recovery w</u>	rell) pump was replaced since the p	revious FYR.

Recovery well DW-8 opened for observation

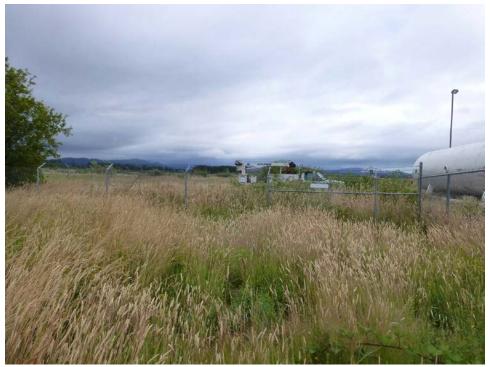
1.	Fencing Damaged Location shown	on site map Gates secured N/A
	Remarks: <u>Some briar growth on fenceline.</u>	
B. Otl	her Access Restrictions	
1.	Signs and Other Security Measures	☐ Location shown on site map ☐ N/A
	Remarks:

Fenceline between main facility and leased CoEnergy area, DW-2 is located at fourth fencepost from the right

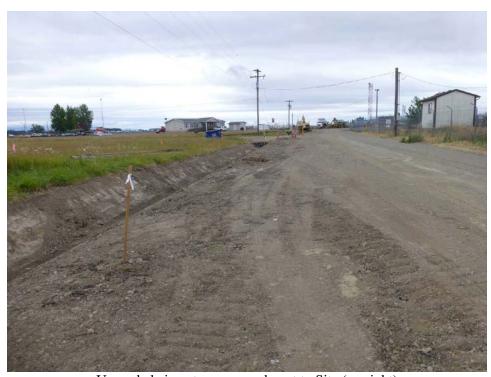
Upgraded airport access road next to Site (on right)

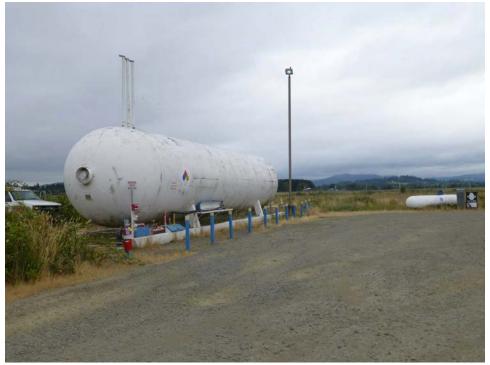
Thirty-thousand-gallon liquefied natural gas tank on property leased by CoEnergy

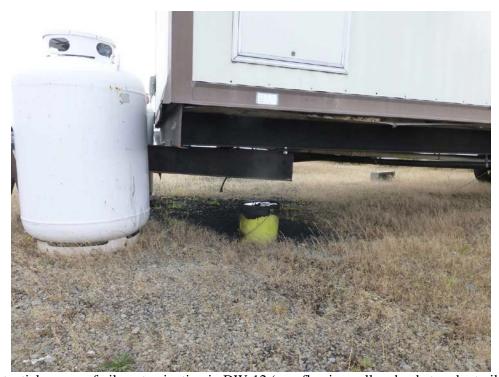
In 2016, oil was found in well DW-12. It appears to have been caused by a trailer stationed on the northeast portion of the Site that was reportedly dripping a black liquid.

In 2016, sampling detected oil in well DW-12. The apparent cause of the contamination is a trailer stationed on the northeast portion of the Site that was dripping a black liquid. This black liquid should be characterized, the well should be cleaned and the source should be removed from the Site.

Potential source of oil contamination in DW-12 (overflowing yellow bucket under trailer)

- In 2016, sampling detected oil in well DW-12. The apparent cause of the contamination is a trailer stationed on the northeast portion of the Site that was dripping a black liquid. The City should ensure well DW-12 is clean and characterize and remove the oil contamination source.

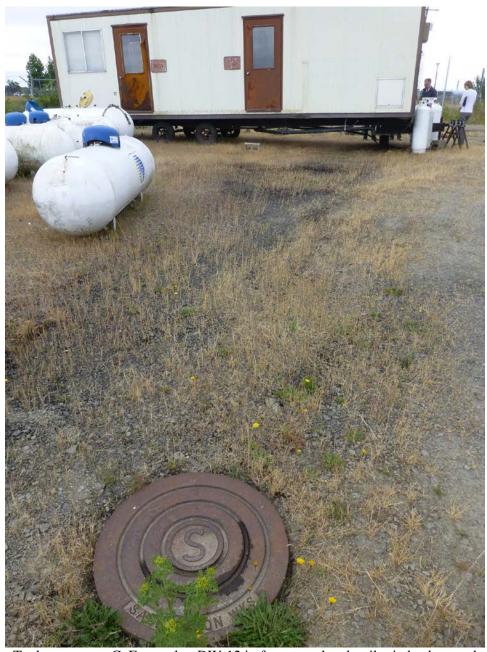
Tank storage on CoEnergy lot, DW-12 in foreground and trailer in background
